Newman Lake Flood Control Zone District 2023 Flood Control Facility Inspection Report

Inspection Date: June 6th, 2023 & October 11, 2023

Participants: Spokane County Engineering/NLFCZD Staff

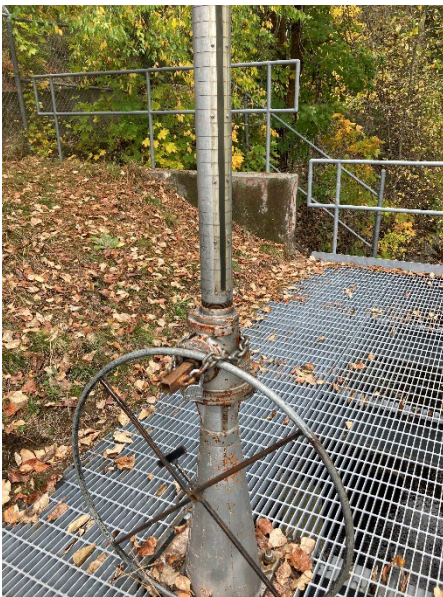
The northwestern gate was opened for a brief check and had difficulty closing fully. There appears to be a slight leak in the northern gate. The southeastern gate was also checked, with no apparent issues observed when opened. As noted in previous inspections, there is still minor rusting on the steel gates and frame around the gate openings on the downstream side. There is also some pitting in the gates; however, it is not structurally significant (Figure 2). The gates and gate control mechanisms will be epoxy-coated in 2024, and the leak will be repaired as well. The wheel used to open the gates is cracked and needs to be re-welded (Figure 1).

Figure 1: Gate wheel showing signs of rust.

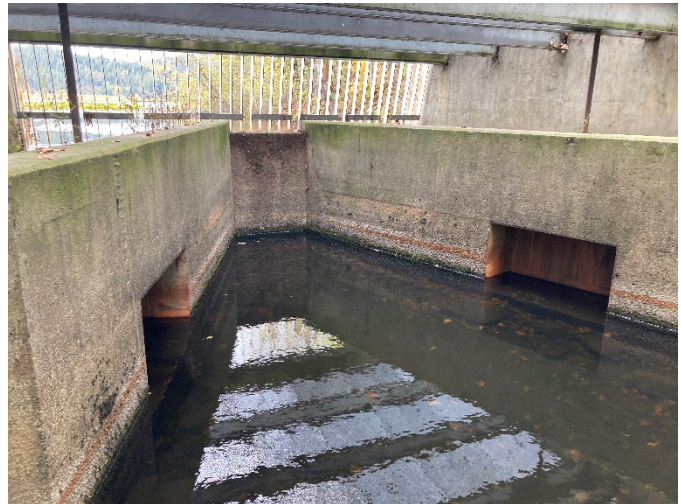
Figure 2: Flood gates need to be repainted. Surrounding concrete shows some pitting.

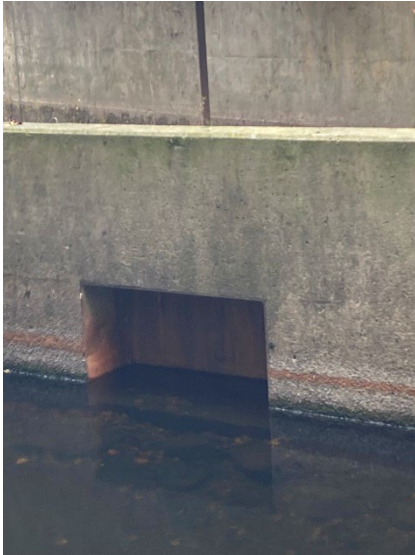
Figure 3: Northern gate is leaking slightly.

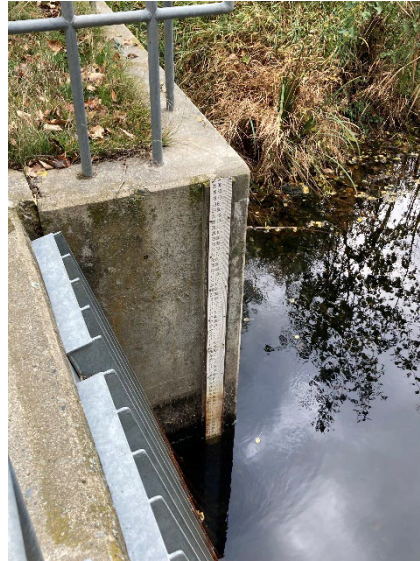
The condition of both gages continues to deteriorate. Both gages are becoming difficult to read below the ordinary high-water mark. The gages will be replaced in 2024 as part of the Newman Lake Capital Budget Grant project (Figure 3, Figure 4).

Figure 4: Outlet channel gage is beginning to deteriorate at water level.

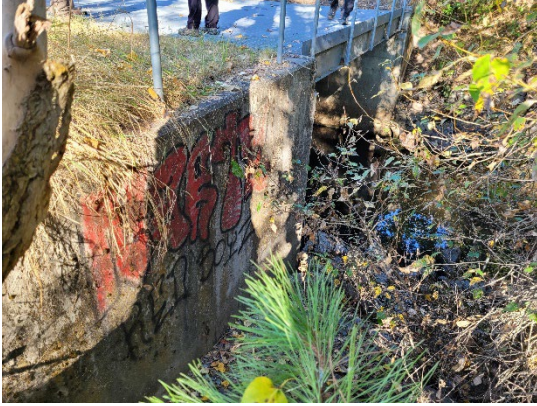
Figure 5a: Graffiti on downstream end of outlet structure.

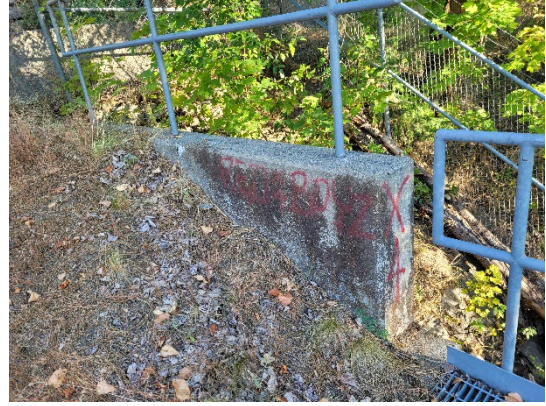
Figure 5b: Graffiti on opposite side of channel from previous figure on the downstream end of the outlet structure.

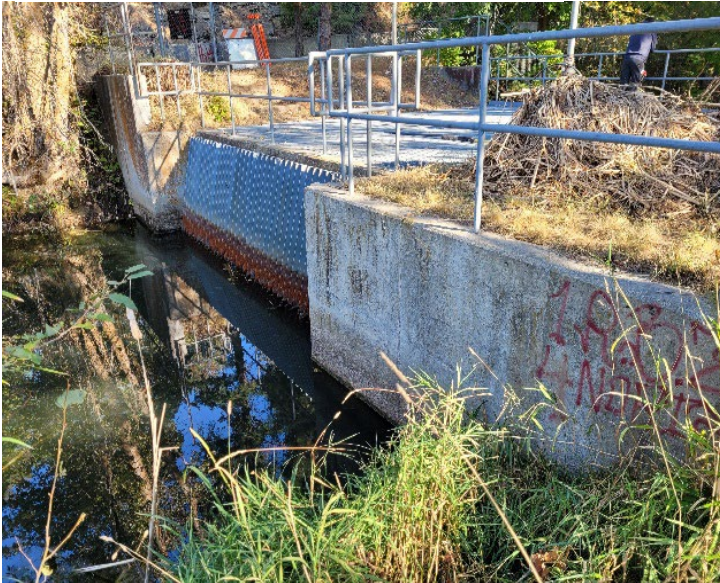
The beams and concrete are still in good condition. There are no cracks in the walls, but there is some concrete pitting below 2123.00 feet. Some spalling on southwest corner of the structure will be monitored. The overflow weir was inaccessible due to water when inspected but appears to be in good overall condition with minimal signs of scour on the downstream side. The downstream riprap is still in place. The deck grating is in good condition and clipped down. There is graffiti on multiple walls of the outlet structure.

Figure 6: Concrete spalling and pitting along with graffiti on upstream side of the outlet structure.

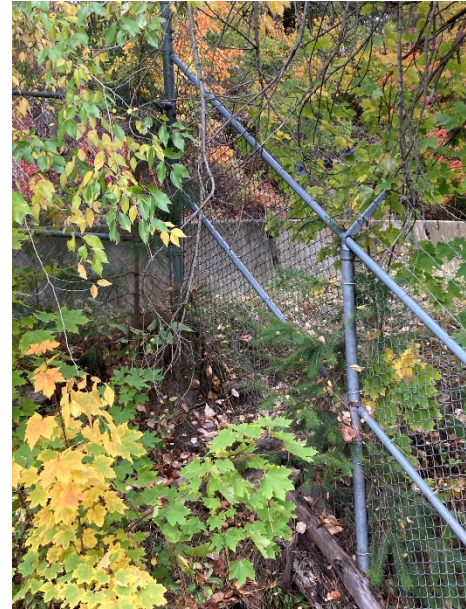
Figure 7: Northwest corner of outlet structure with a hole in the chain link fence.

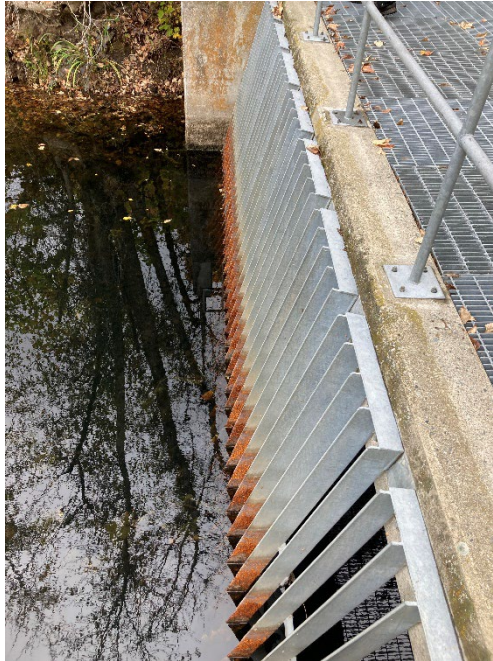
The trash rack has surface rust below 2125.50 feet but is still in acceptable condition (Figure 8). It should be painted with an epoxy coating at the same time that the gates are painted to prevent further corrosion. Debris and aquatic plants are removed from the trash rack during periodic gage readings performed by staff. Gages at this location are also beginning to be difficult to read.

Figure 8: Some corrosion on trash rack.

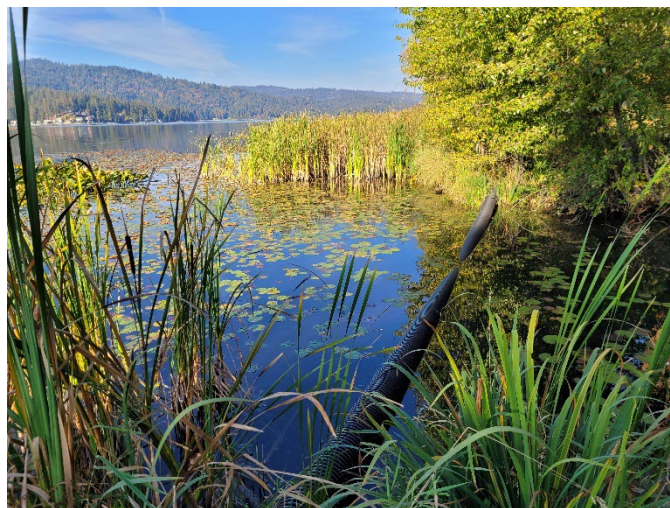
The log boom broke in the spring but was repaired to good condition and appears to be functioning well (Figure 9).

Figure 9: Log boom is still in good condition

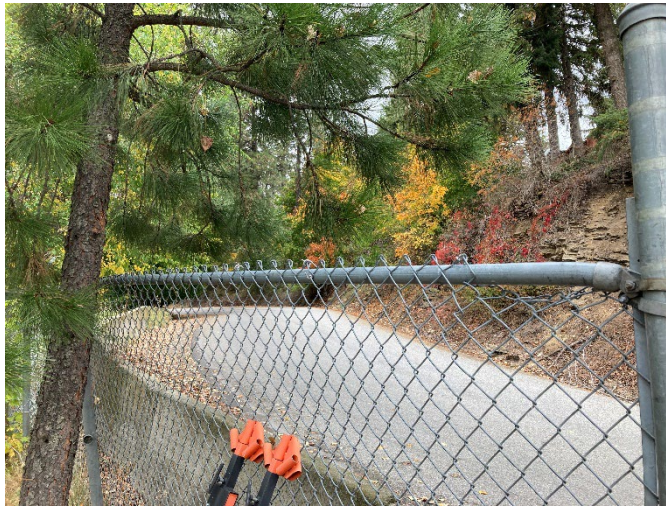
Figure 10: Barbed wire cut on eastern side of gate

- There is a hole in the chain link fence that could potentially allow access to the outlet gate (Figure 12). In addition, there is barbed wire that has been clipped (Figure 10). These repairs will be a priority at the start of 2024.

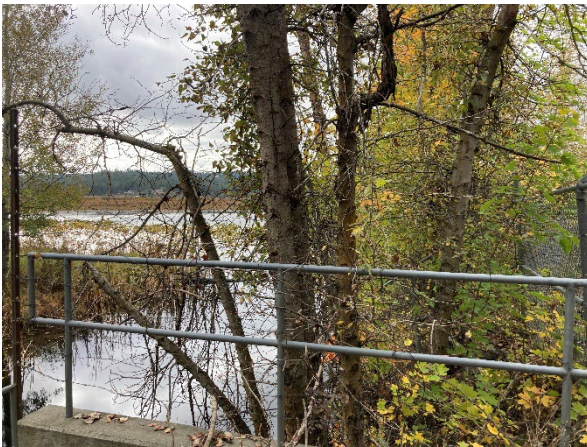
Figure 11: View looking toward the lake. Barbed wire needs to be tightened.

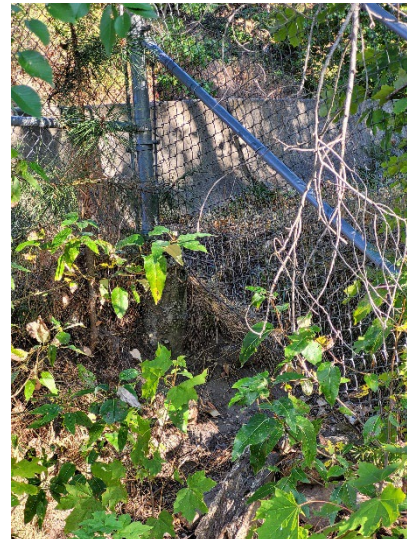
Figure 12: Hole in chain link fence at outlet structure.

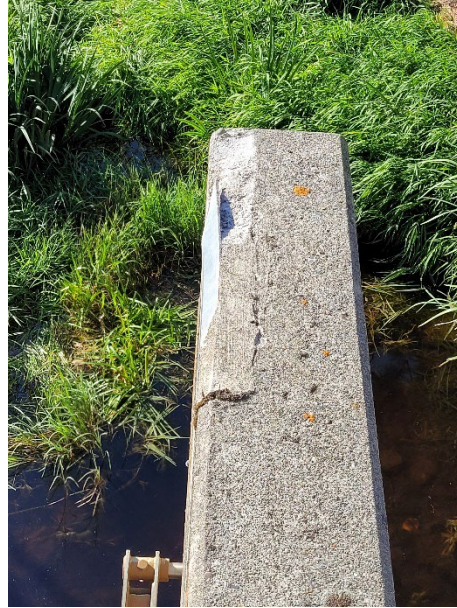
Water Level: 2120.75 feet (NAVD 88) Overall, the structural integrity of the channel water control structure is good, as in previous years (Figure 13). The concrete is still in acceptable condition with the exception of some spalling at the top of the roll gate (Figure 14). The repair is planned to occur in 2024 with the other structures. As noted since 2007, there are small cracks at the corner of both abutments (Figure 14). They do not appear to have changed significantly since last year, but staff will continue to monitor the cracks. The west side wing wall crack is still approximately 3/10 inch wide.

Figure 14: Concrete spalling at the top of the roll gate and corner of abutment.

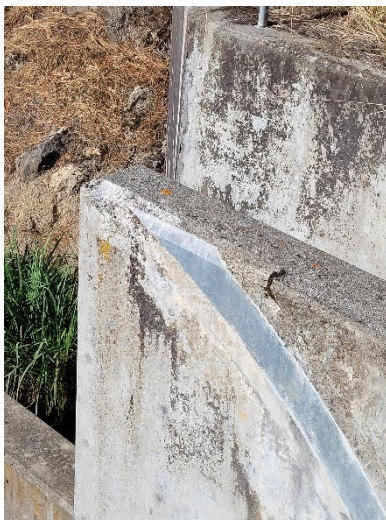
Figure 15: Spalling on roll gate

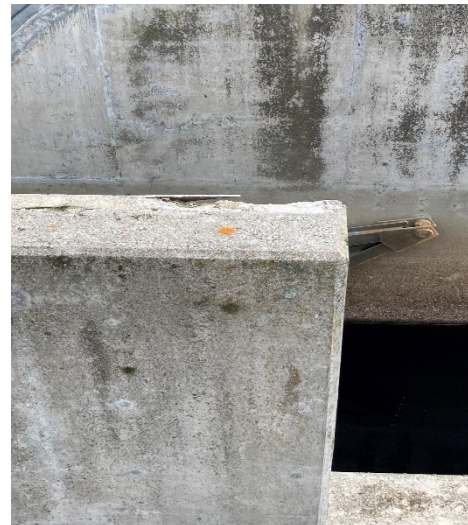
Figure 16: Spalling viewed from otherside

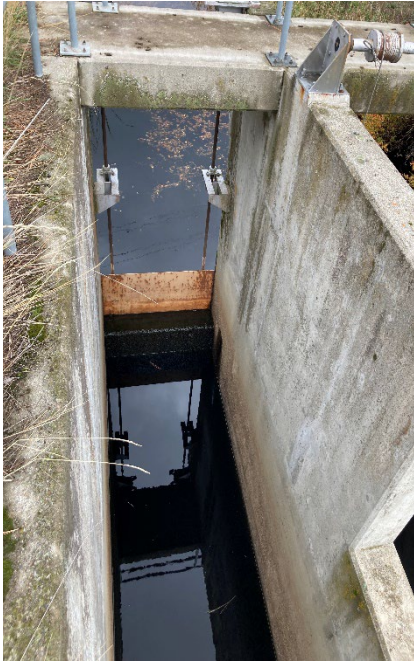
Neither gate was tested during the facilities inspection, but the radial gate was opened by County staff laster in October with no issues. The weir gate is currently not functional and needs to be repaired. There is a small amount of water flow that passes through the gate currently in its closed position. (Figure 16).

Figure 17: Weir gate closed during inspection.

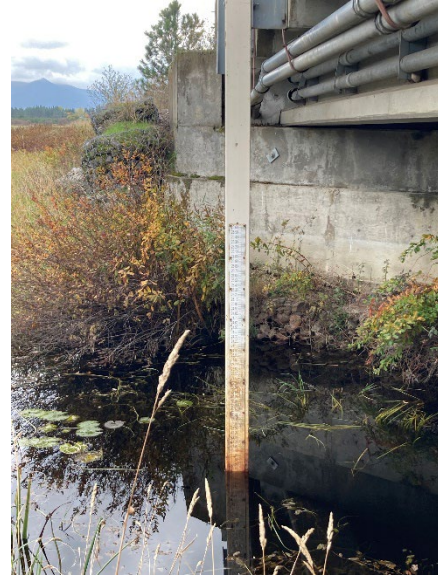
The stretch of channel between the outlet structure and Starr Road Bridge is well vegetated with grasses and lily pads. The channel banks appear to be in fair condition with some gradual sloughing and moderate bank failure downstream of the outlet gate. The bank condition will continue to be monitored for sloughing progression. There is some natural channel meandering beginning upstream of the Starr Road Bridge (Figure 19). The channel will be monitored for erosion and any necessary stabilization. Lily pad growth will also be monitored. The staff gauge at Starr Road Bridge is rusting and becoming difficult to read beneath the ordinary high-water mark (Figure 20). It will be replaced in the near future as part of the Newman Lake Capital Budget Grant project.

Figure 16: Staff gage at Starr Road Bridge is becoming difficult to read.

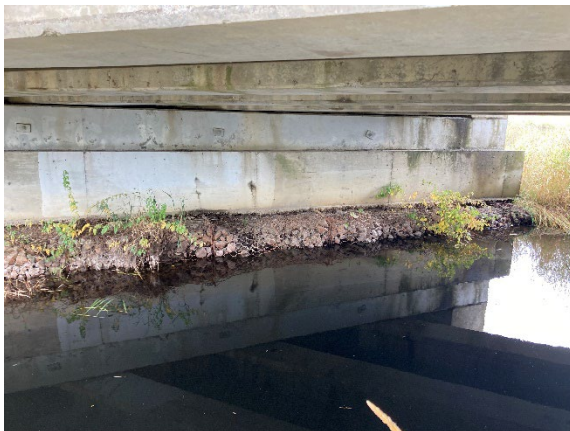
The gabion baskets along Starr Road Bridge are being eroded and are undercut. The gabions are canted approximately two feet from the bridge at the northwest and southwest corners of Starr Road Bridge (Figure 23, Figure 24). However, the baskets seen in Figure 24, and then on the other side of the road, but same side of channel, have not deteriorated since last year. The gabion baskets underneath the bridge deck have broken away from the bridge (Figure 24). The gabion baskets will need to be stabilized in the near future.

Figure 19: Gabion baskets beneath the bridge deck are separating from the bridge and deteriorating.

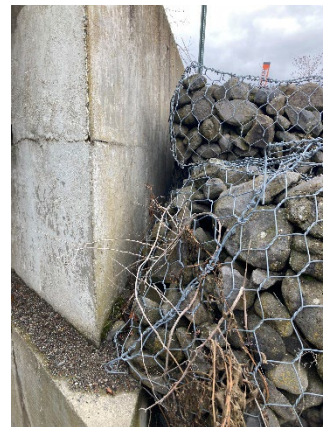
Figure 20: Gabion baskets at southwest and northwest corner of Starr Road Bridge are pulling away from the bridge.

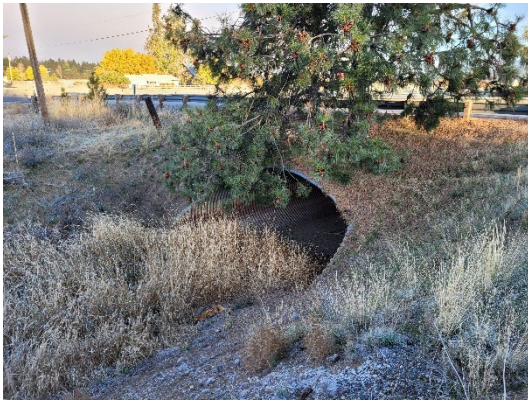
The channel banks are in good condition and well vegetated between the channel water control structure and the culvert at Moffat Road (Figure 25, Figure 26). There is a pine tree growing above the downstream side of the Moffat Road culvert (Figure 27), but the culvert still appears to be in good condition (Figure 28). The culvert will be monitored for any future damage.

Figure 23: Pine tree growing above Moffat Road culvert.

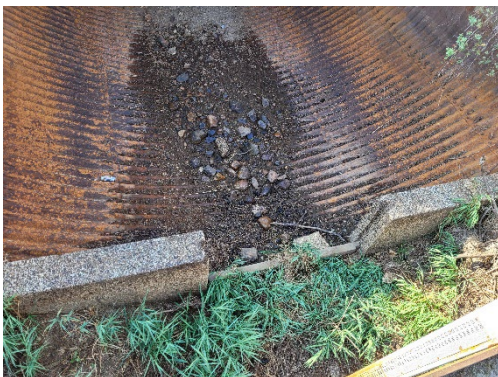
The weir upstream of the Moffat culvert is missing its weir boards (Figure 29). The gage at Moffat Road has some rust and is covered with vegetation that needs to be removed (Figure 30). The staff gauge will be replaced in the near future as part of the Newman Lake Capital Budget Grant project.

Figure 25: No weir boards are present.

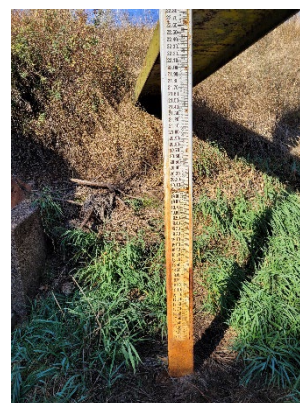
Figure 26: Staff gage is difficult to read and vegetation needs to be removed.

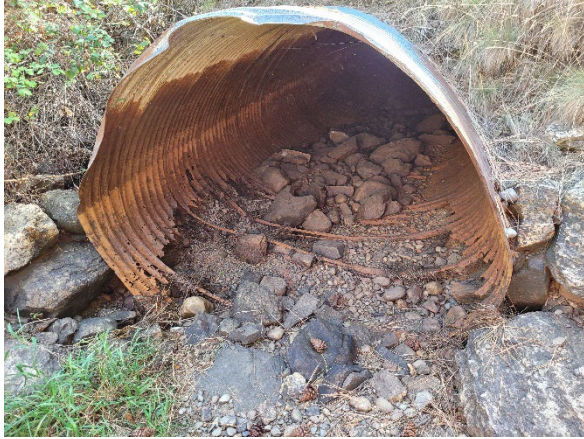
The bottom of the Lincoln Road culvert is still deteriorating. Noticeable undermining of roots for two pine trees located on top of the Lincoln Road culvert was observed. The undermining will be monitored for future damage. The culvert is also beginning to compress due to road traffic pressure. There is some concern with the bank stabilization near Eller's Pond, but it hasn't noticeably changed since the 2012 inspection. Fallen trees, brush and wood debris were removed within the main channel by the clean-up crew in October. As noted in a previous report, there is erosion and sloughing of the driveway edge above the middle culvert of Eller's driveway at Marve Lane. The hole over the middle culvert noted in the 2019 Inspection report has reappeared. Additional rocks and damage on the inlet side of all 3 culverts were observed. Discussions to repair the culverts have not progressed.

Figure 28: Lincoln Rd culvert deterioration

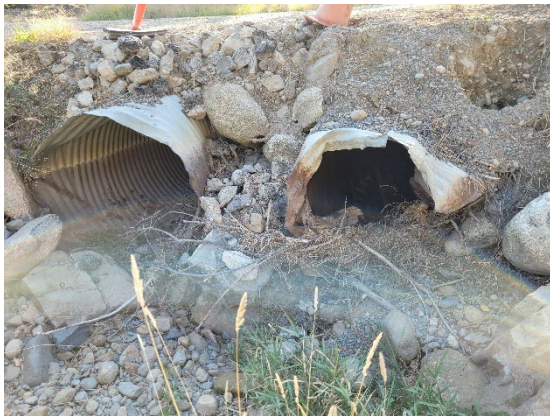
Figure 30: Close up of an Eller driveway culvert inlet

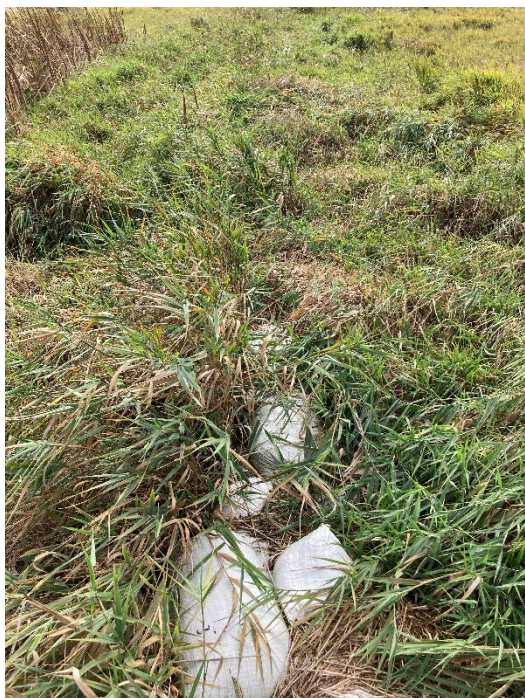
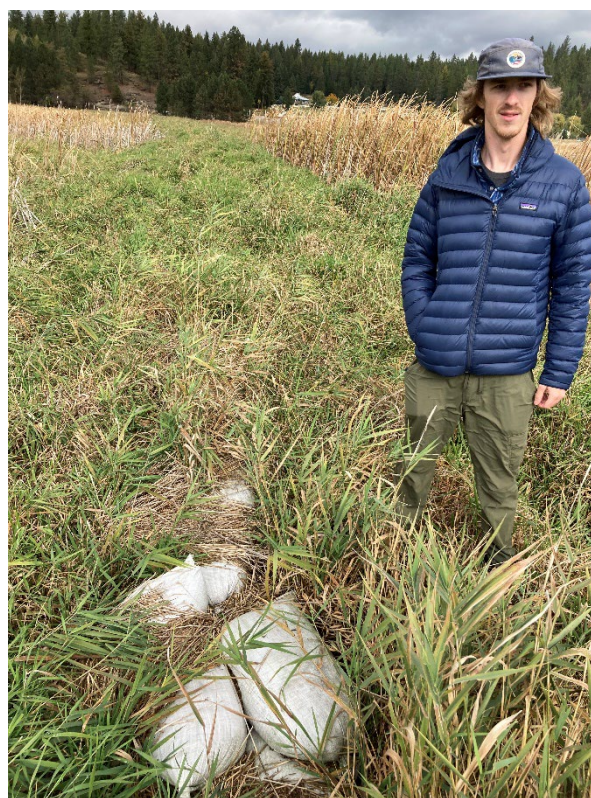
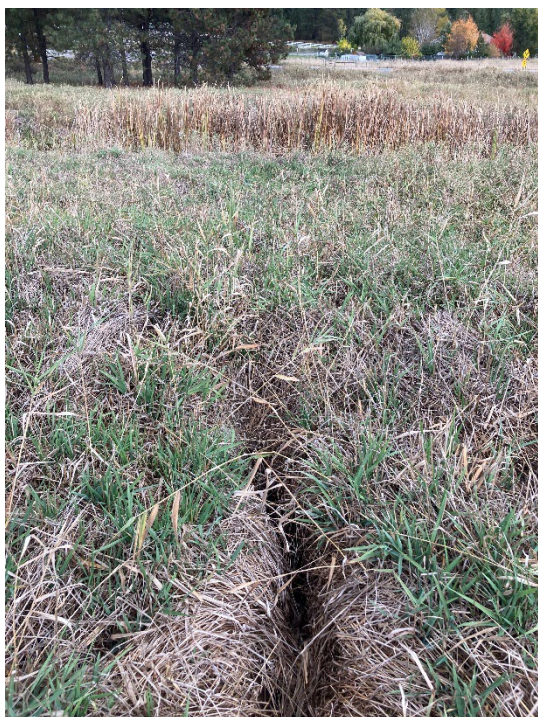
Location 1: Sandbags and cracks along dike near Starr rd.

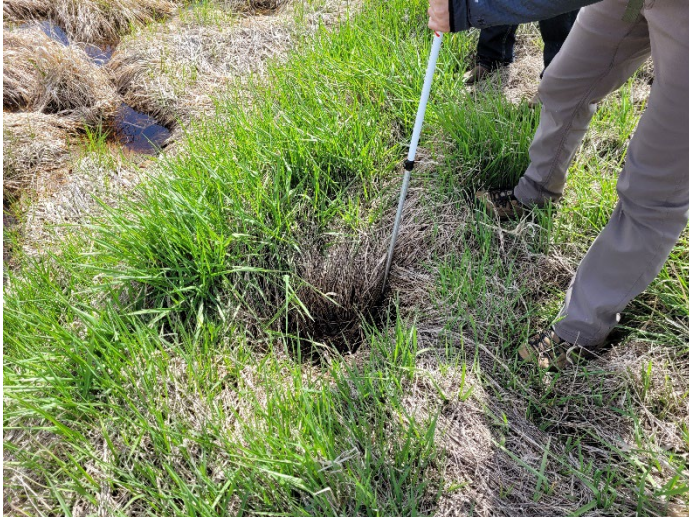
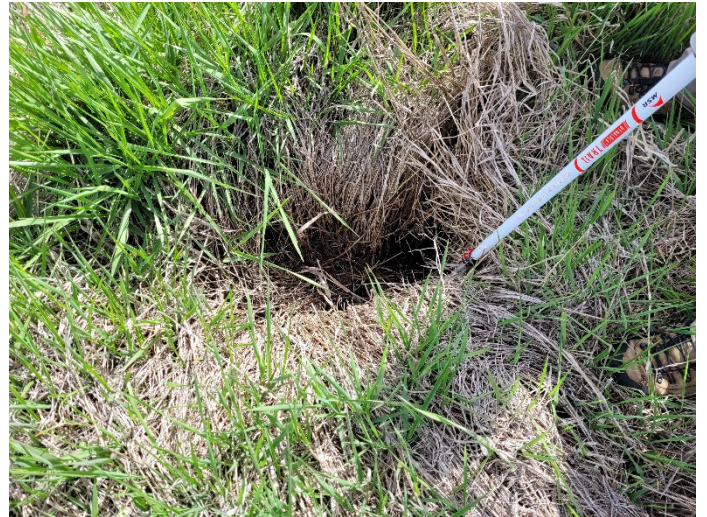
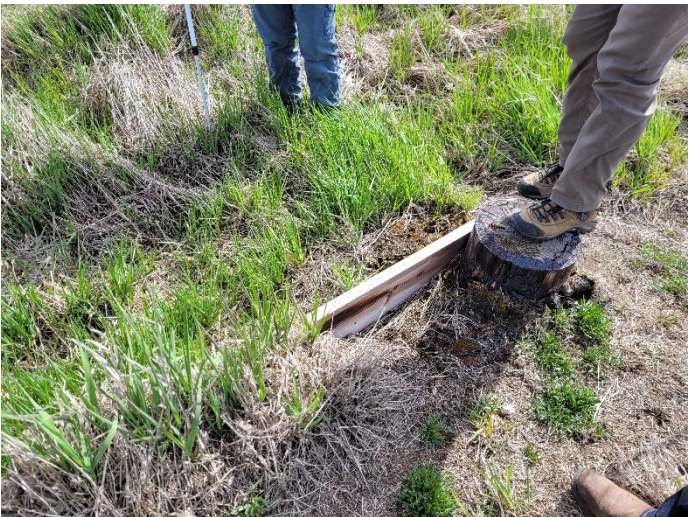
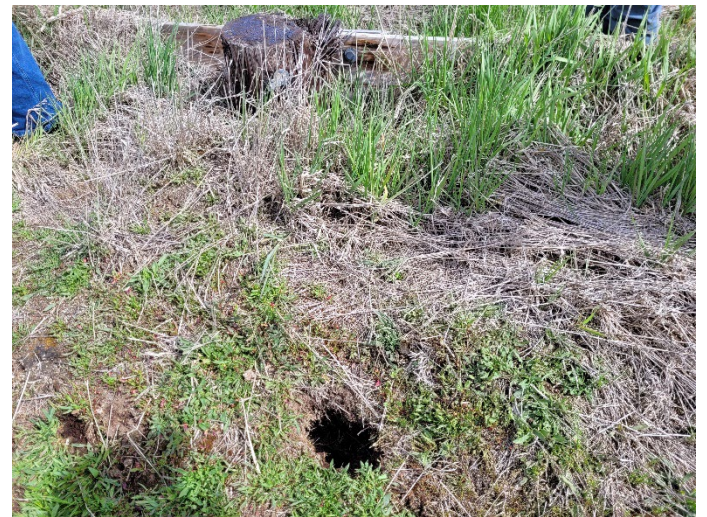
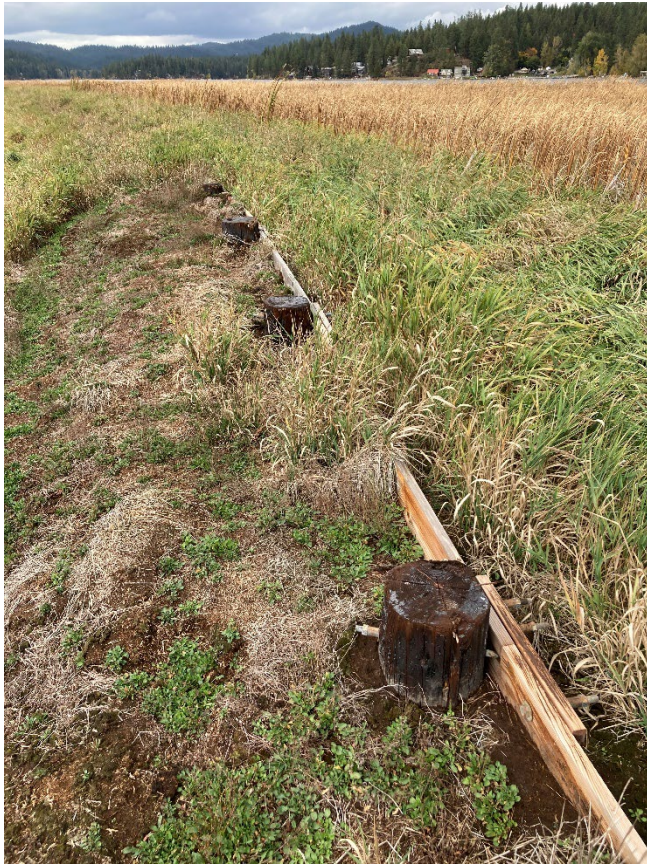
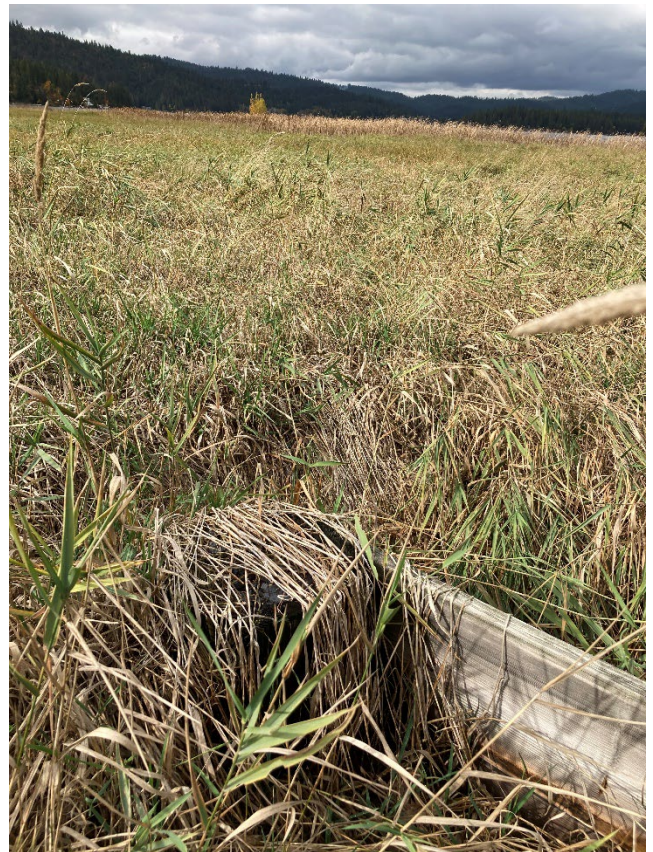
Location 2: Deep animal burrows and holes next near piles installed from previous dike maintenance. Also shown is rut that runs alongside piles on the lake side of the dike with a few feet of ground elevation difference.

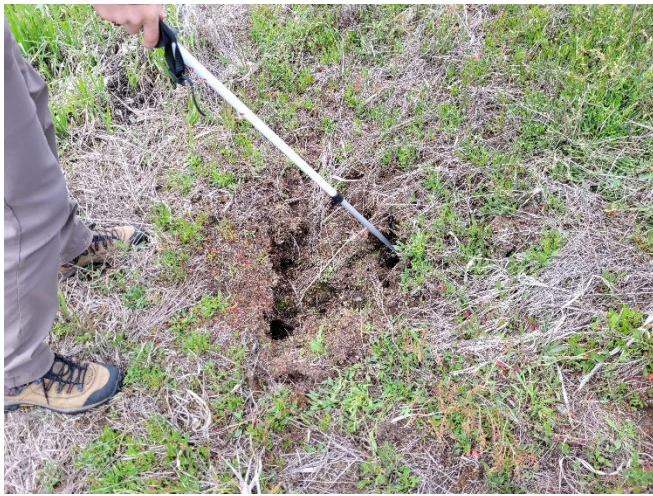
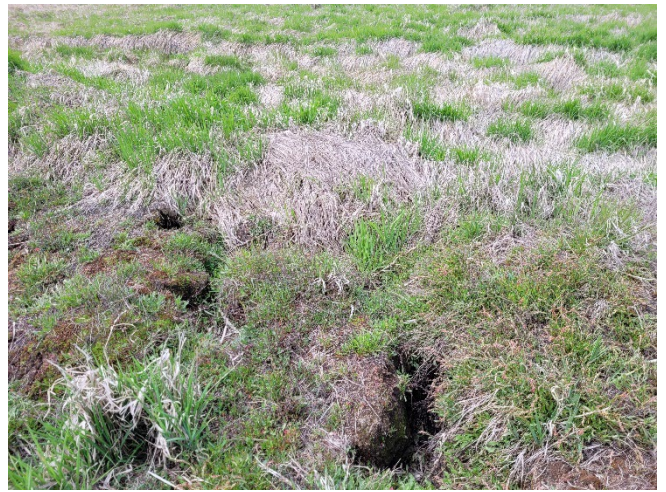
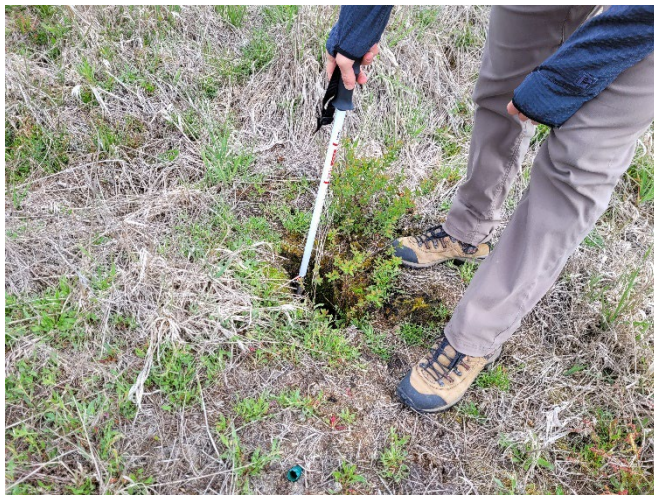
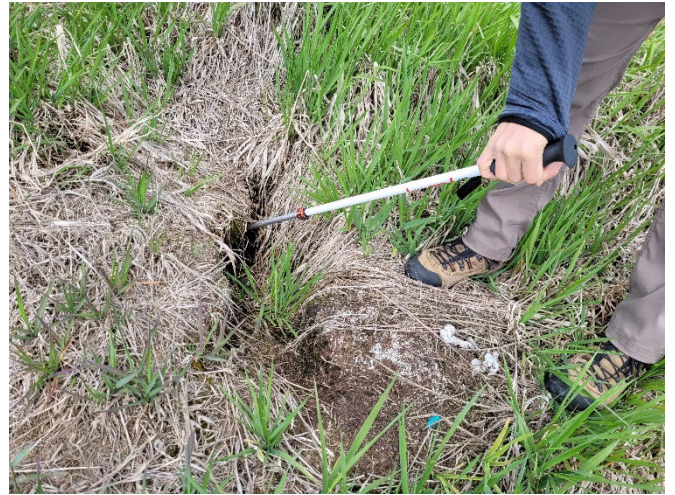
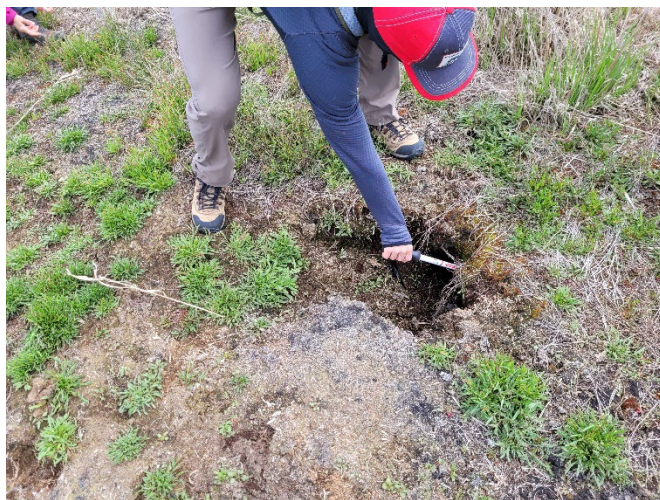
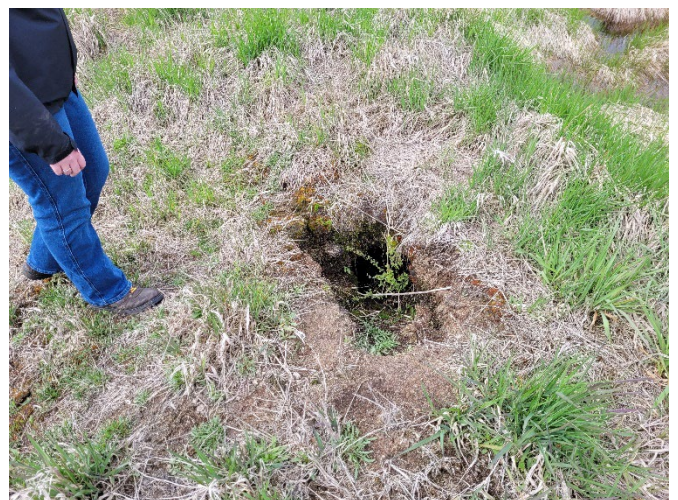
Location 3: Deep holes, cracks and animals burrows in this area are shown below.
